### Construction Site Visit – Casita

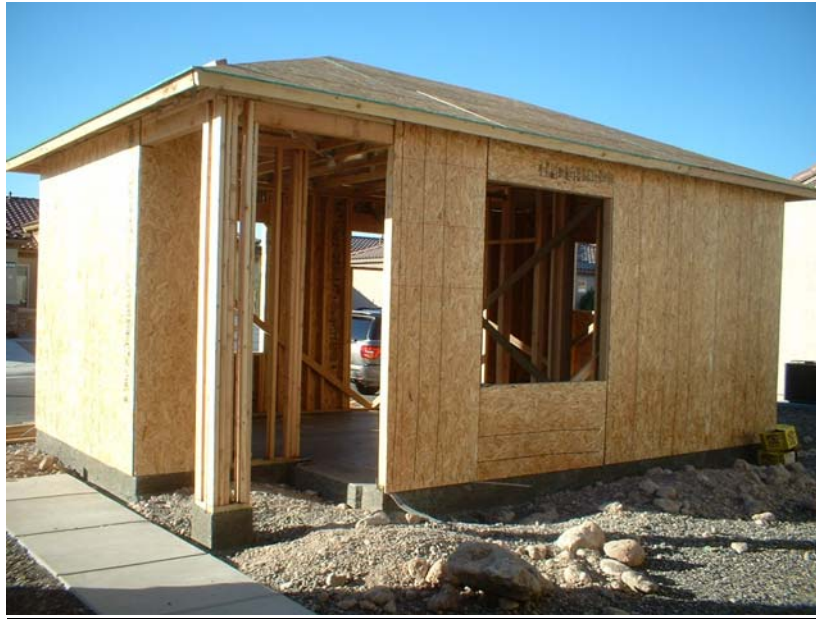
This is a picture of the outside framing of the casita. The construction process first began with laying the concrete slab, then erecting the structure. All of the outside framing members were made of oriented strand board, a new trend in residential construction. It amazed me how strong and sturdy these members were. In the following pictures, we'll get a look at the interior framing of the structure.

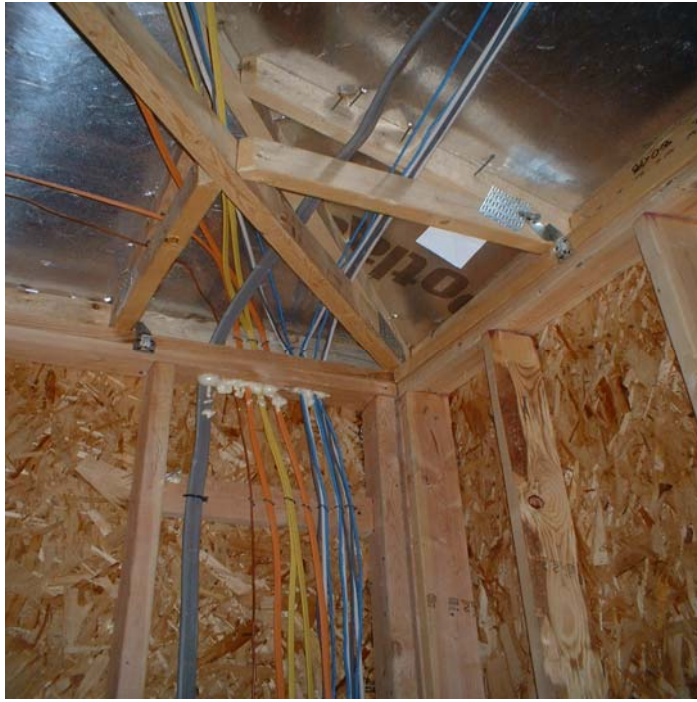
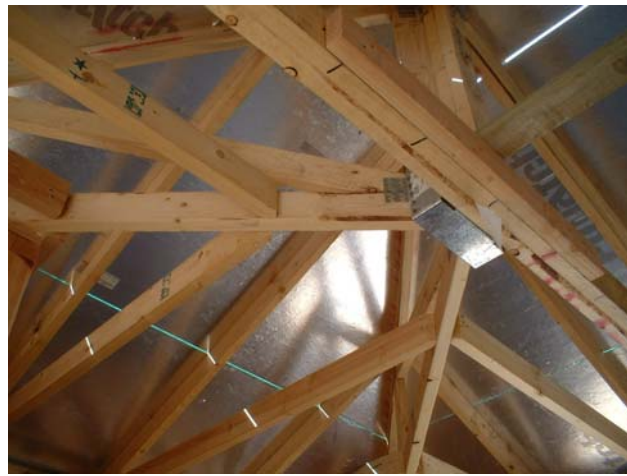
The following pictures contain shots of roof members and rafters within the casita. What really stood out to me is the complexity of the members that make up the joints.

The first picture depicts a corner section of the roof. Here we can see roof members and columns coming together to form the corner joint. Standard 2x4 and 2x6 members were used in the frame. Note the close-up view of the OSB walls. The oriented strand board, comprised of wood chips compressed together, has a very interesting look as is surprisingly sturdy. The second picture depicts a joint within the roofing system, a surprisingly complex member with what appears to be a great deal of redundancy.

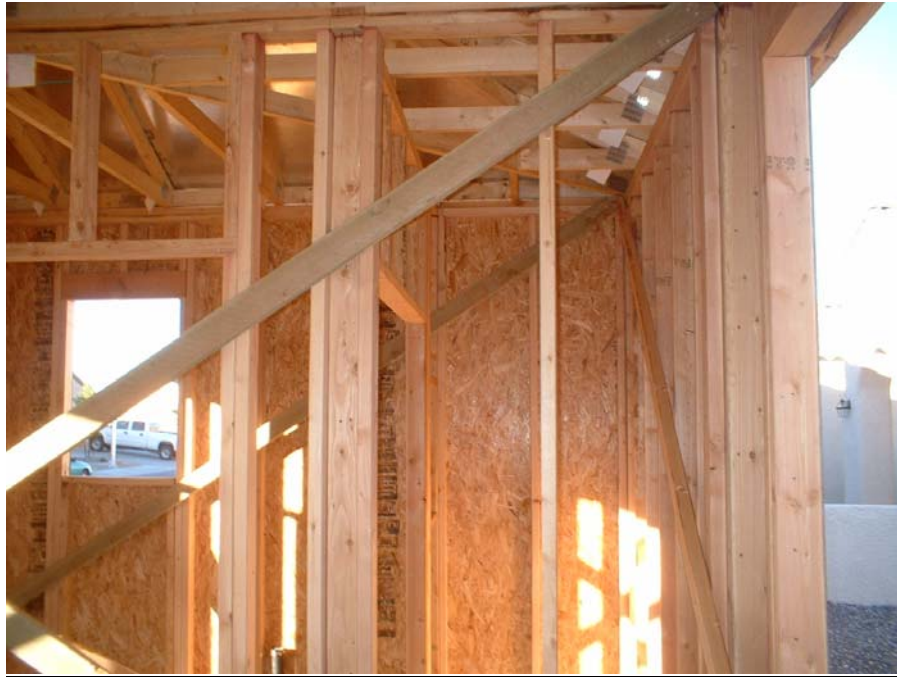
The following pictures contain images of the temporary cross-bracing within the walls of the casita necessary during the construction phase. These braces are necessary for stability and strength until the construction is completed. Note that in both these pictures, the cross-bracings go right in front of a doorway, implying their temporary status.

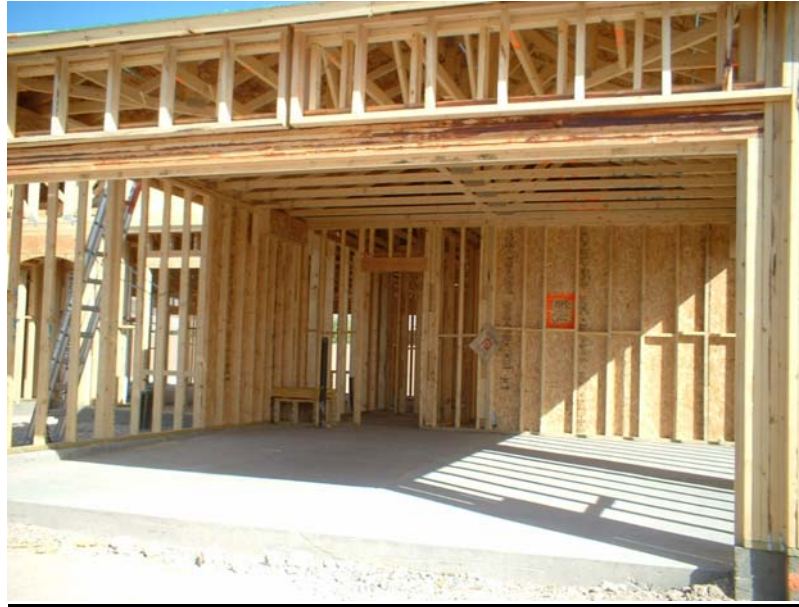
Lastly, I wanted to reference a few photos from the construction of our garage because we had a similar task in our fourth homework of constructing a garage with wood members. Note in this first picture the simple column supports at equal spacing, very similar to our homework.

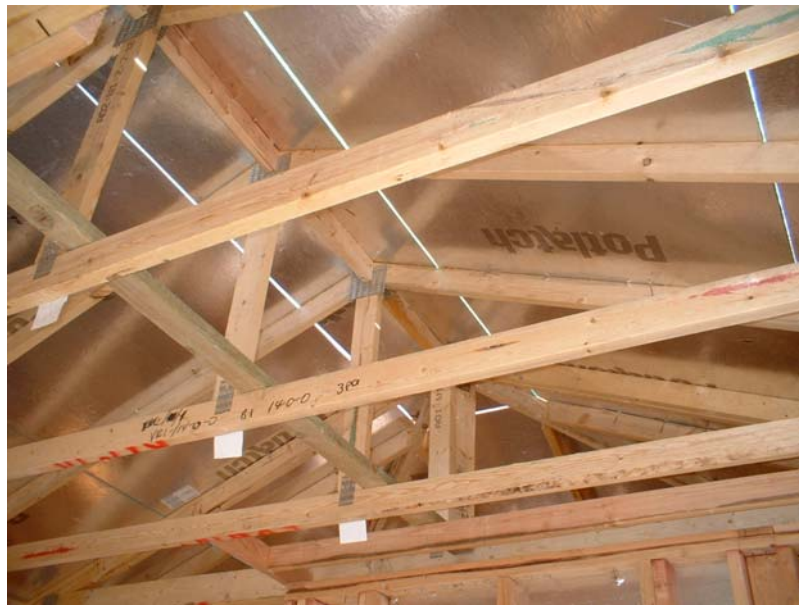
This picture has a good view of the roof trusses. Very similar to our homework, identical roof trusses are constructed then spaced evenly apart. Such a simple roof truss can provide a lot of support, and I'm thankful for that to this day as our cars have been well-protected.
